# Inspection Report Summary

| Machine: | 10 Corrugator - Wet End - Agnati Incline Web System to Deck |
| Inspected Date: | Jul 17, 2025 |

**Facility:** Cascades Winnipeg

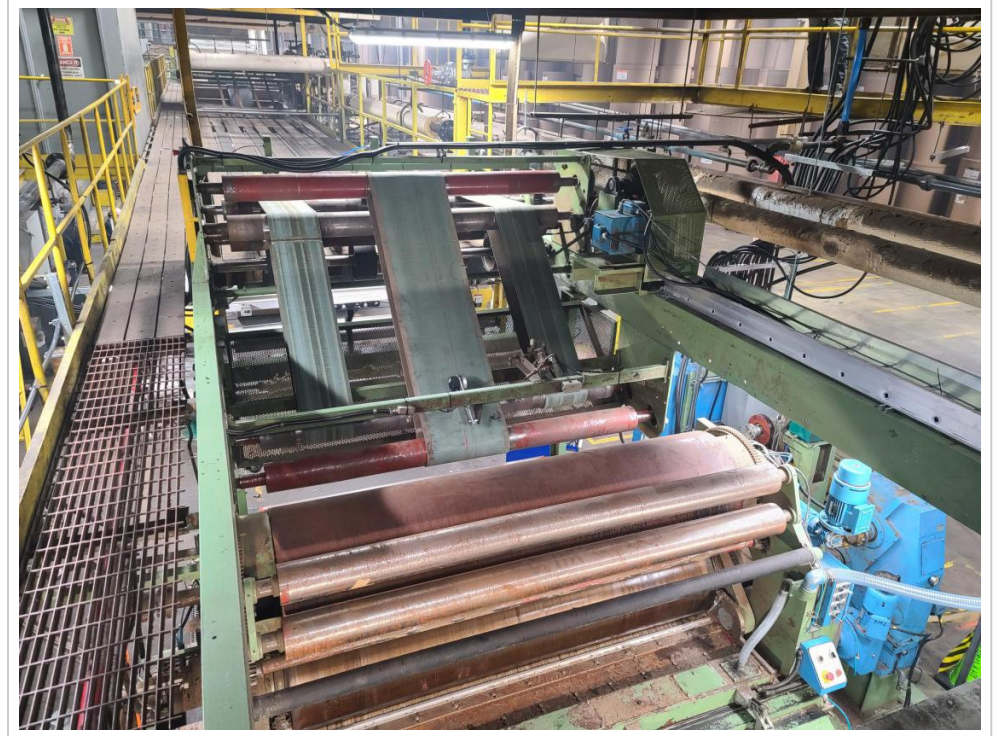
**Machine:** 10 Corrugator - Wet End - Agnati Incline Web System to Deck
