# Inspection Report Summary

| Inspected Date: | May 13, 2026 |

**Facility:** Acadia Junior High

**Machine:** Bambu 3D Printer

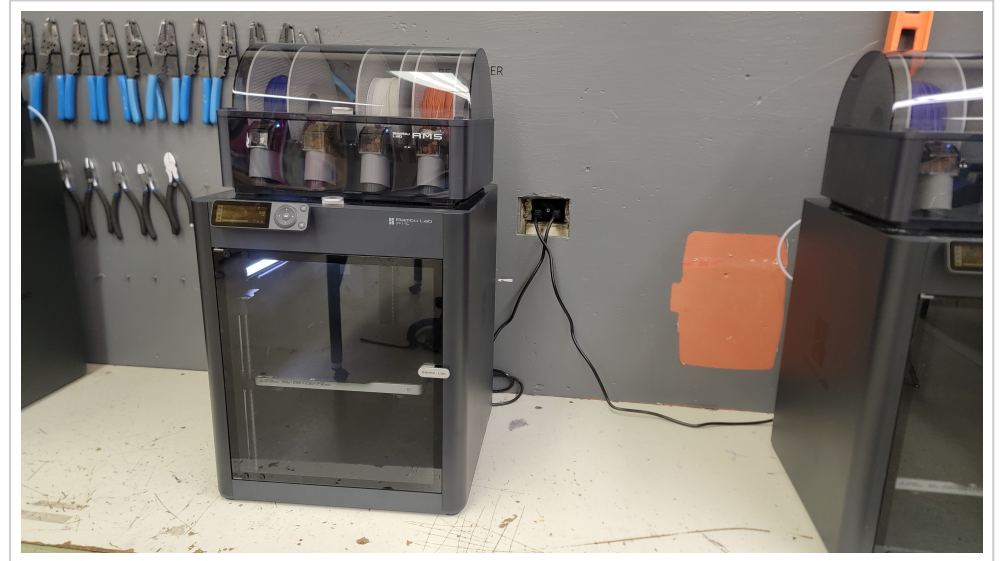
| Activity/Tasks | Hazards | Corrective Action | Pass/Fail | Severity | Exposure | Avoidance | Total | Current Safeguards | Recommended Improvements |
|---|---|---|---|---|---|---|---|---|---|
| Print part | Burn, entanglement , crush | | Pass | 1 | 2 | 2 | PR2<br>4 | Full enclosure | |

| # | Question | Corrective Action | Pass/Fail |
|---|---|---|---|
| 1. | Safe Work Procedure posted? | 2026 Inspection - Create safe work procedure for printers | Fail |
