# Inspection Report Summary

| Machine: | Bambu 3D Printer |
| Inspected Date: | May 13, 2026 |

**Facility:** Acadia Junior High

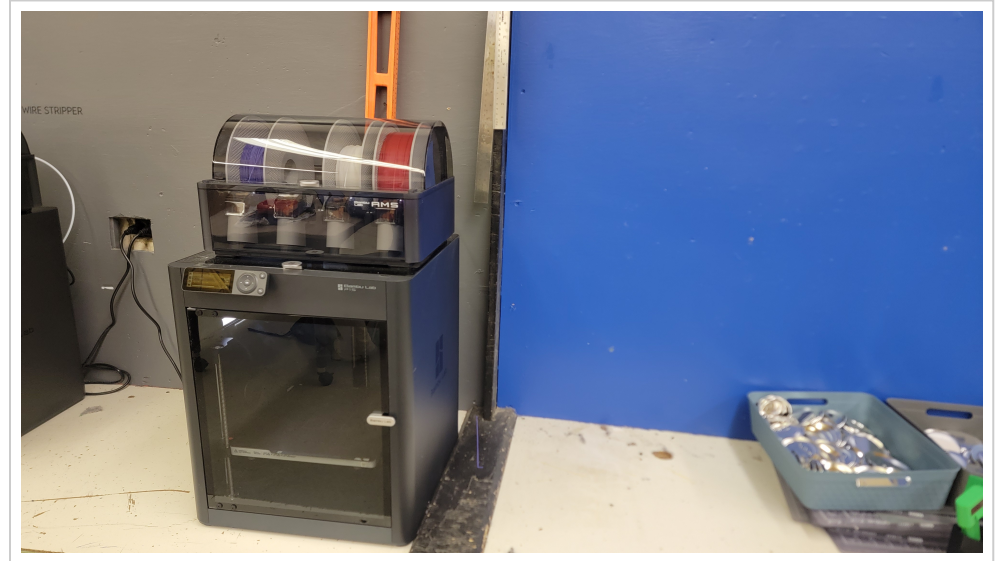
| Activity/Tasks | Hazards | Corrective Action | Pass/Fail | Severity | Exposure | Avoidance | Total | Current Safeguards | Recommended Improvements |
|---|---|---|---|---|---|---|---|---|---|
| Print part | Burn, entanglement , crush | | Pass | 1 | 2 | 2 | PR2<br>4 | Full enclosure | |

| # | Question | Corrective Action | Pass/Fail |
|---|---|---|---|
| 1. | Safe Work Procedure posted? | 2026 Inspection - Create safe work procedure for printers | Fail |
