# Inspection Report Summary

| Machine: | CamTool CNC Router |

# Inspection Report

**Facility:** Shaftesbury High School

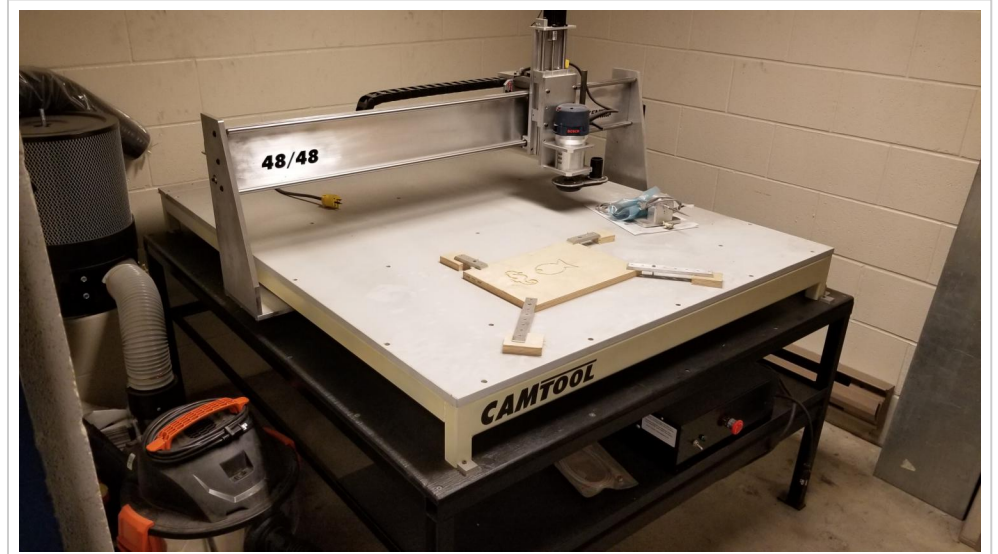
| Activity/Tasks | Hazards | Corrective Action | Pass/Fail | Severity | Exposure | Avoidance | Total | Current Safeguards | Recommended Improvements |
|---|---|---|---|---|---|---|---|---|---|
| Operate machine | Laceration, entanglement in cutter. Struck by carriage. | | Pass | 2 | 2 | 2 | PR18 | Enclosed in room with interlocked door | |
| Third party access | Laceration, entanglement in cutter. Struck by carriage. | | Pass | 2 | 2 | 2 | PR18 | Enclosed in room with interlocked door | |
| Watch operation of machine | Unable to properly watch cutting process and identify hazardous conditions | | Pass | 1 | 2 | 2 | PR24 | Enlarge window in door | |
| Set up machine or empty dust collector | Trip on power cord | | Pass | 1 | 2 | 2 | PR24 | Electrical outlet behind machine to eliminate tripping on cord | |
| Operate machine | Exposure to dust and debris | | Pass | 2 | 2 | 2 | PR18 | Interlock dust collector to machine operation | |
| Set up parts | Struck by parts not secured to table | | Pass | 2 | 2 | 2 | PR18 | Secure Room | |
| Operate machine | Entangle, crush, struck due to failure of safety system | | Pass | 2 | 2 | 2 | PR18 | Category 3 safety circuit | |
